Chlorinated Compounds in Hydrocarbon Streams Using a Halogen Specific Detector (XSD)

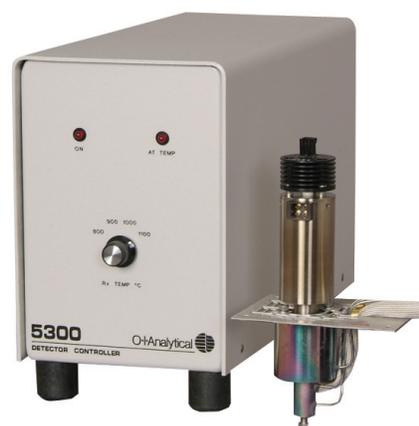
Model 5360A XSD

The instrumentation used was an Agilent 7890A Gas Chromatograph and OI Analytical 5360A XSD. The XSD operates as a thermionic emission detector optimized for the detection of halogen compounds. The detector assembly consists of a ceramic probe with a platinum coil and bead inserted into a high temperature reactor. The GC column effluent is combusted in a stream of air and passed over the bead. The elevated temperature of the reactor causes alkali metals atoms to be released from the ceramic probe and deposited on the bead. The halogenated compounds in the effluent react with the alkali metal atoms on the surface of the bead which results in an increase in thermal electron emission. The measured emission current is proportional to the mass of halogen produced.
